# Village of Caroline

## Capital Infrastructure Plan

Prepared for:  
Village of Caroline

December 13, 2024

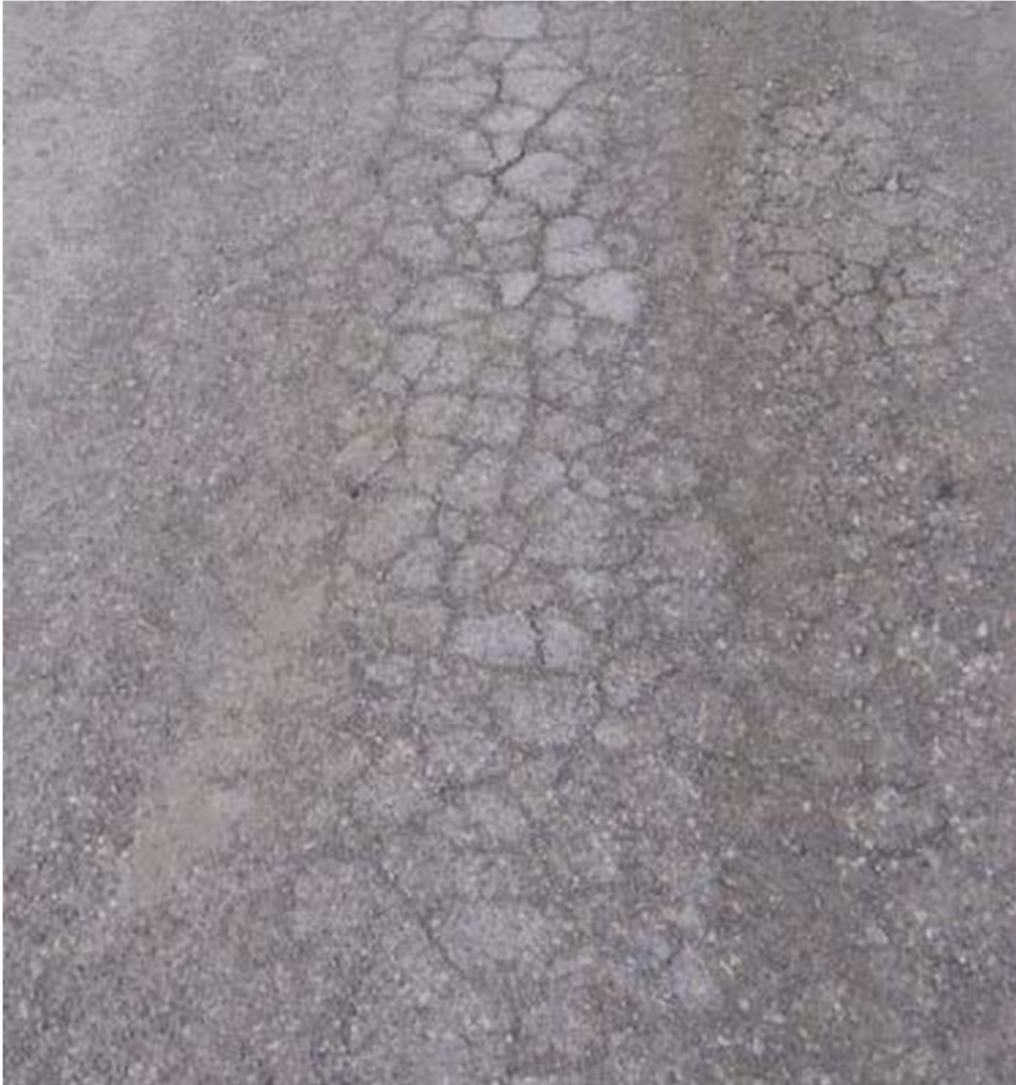
**Fatigue Cracking**

Occurs in areas subjected to repeated traffic loadings and can be a series of smaller interconnected cracks in early stages development which further develop into many sided pieces usually less than 0.3 metres on the longest side. In later stages chicken wire/alligator patten cracking is generally apparent. In extreme cases of fatigue cracking individual pieces of asphalt may move when subjected to traffic loading. The photo below is an example of moderate to severe fatigue cracking.

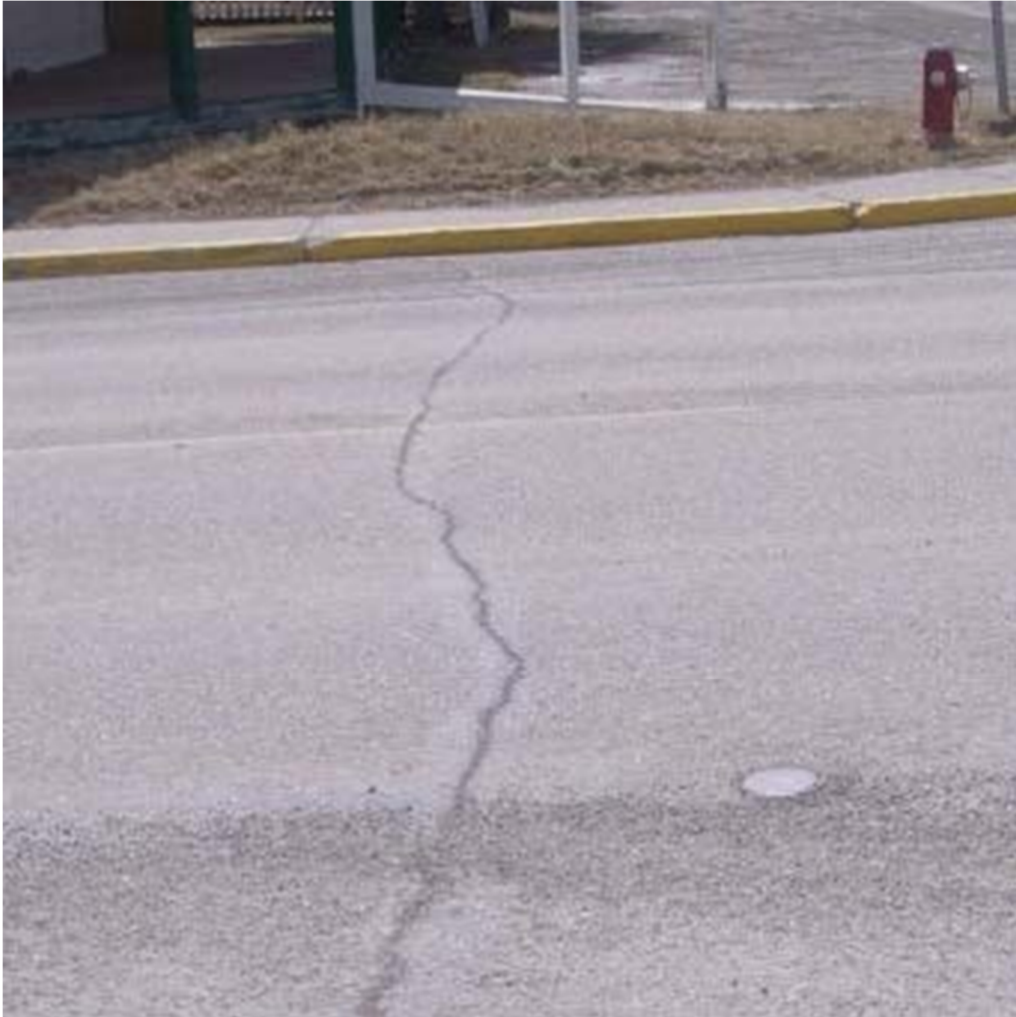
*Transverse Cracking*

Cracks that are predominantly perpendicular to the centerline of the roadway. The photo below is an example of moderate transverse cracking.

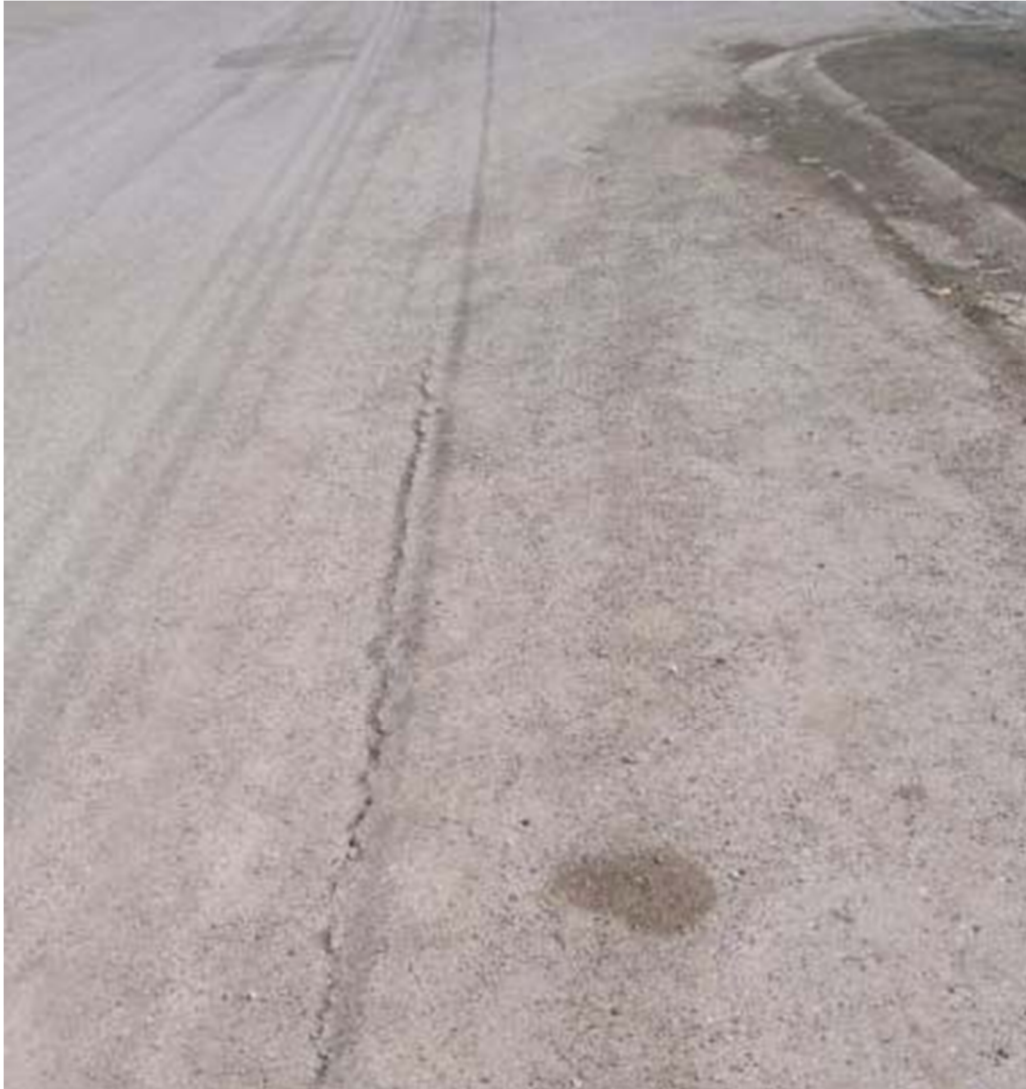
**Longitudinal Cracking**

Cracks that are predominantly parallel to the roadway centre line. The photo below is an example of moderate longitudinal cracking.

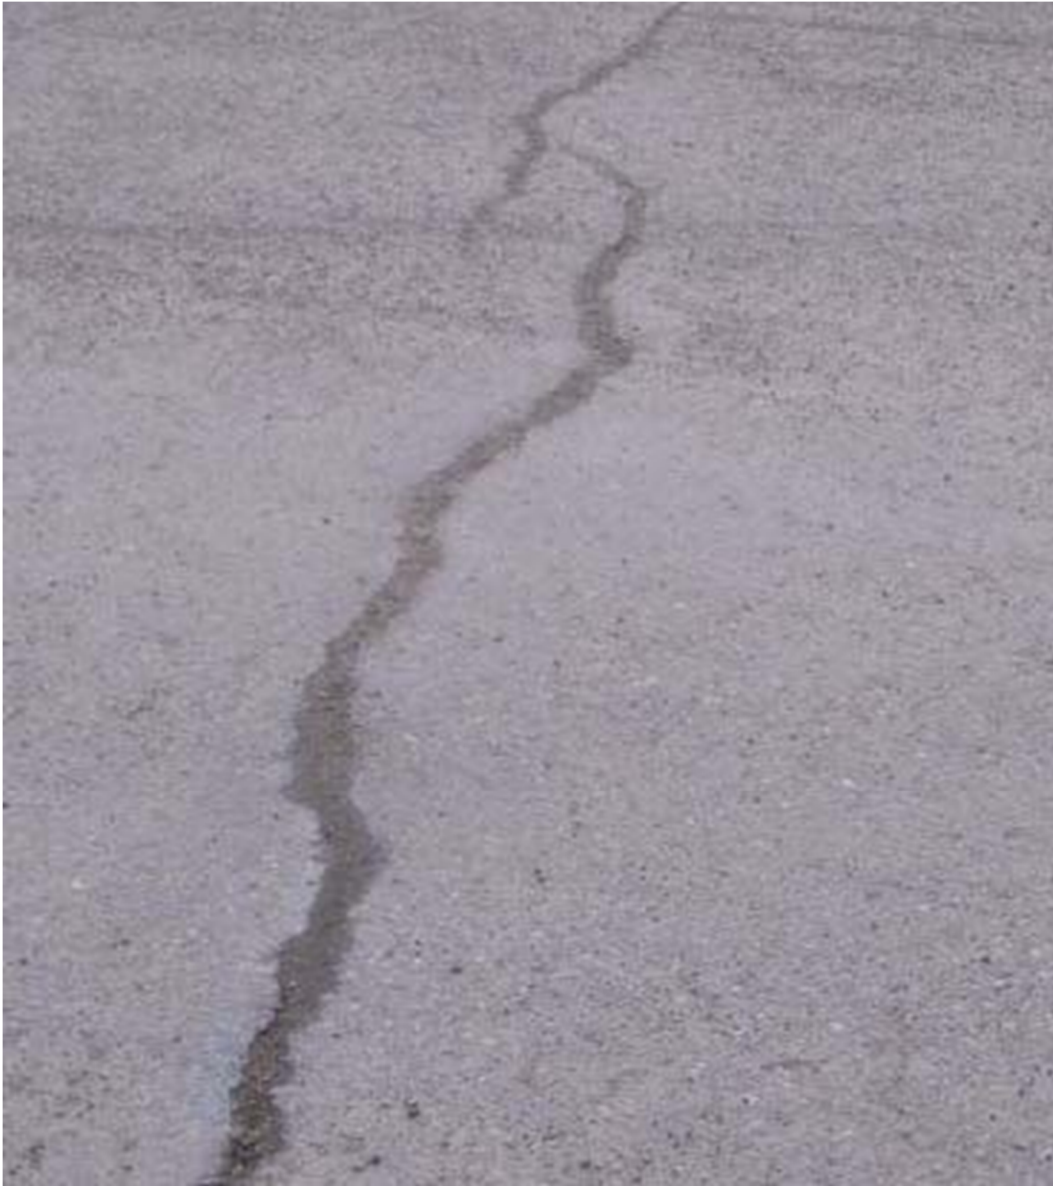
*Pumping (Water Bleeding)*

Seeping or ejection of water from beneath the pavement through cracks. In some cases, detectable by deposits of fine material residue on the pavement surface where were eroded (pumped) from the granular support structure of the roadway onto the surface. The photo below is an example of moderate pumping.

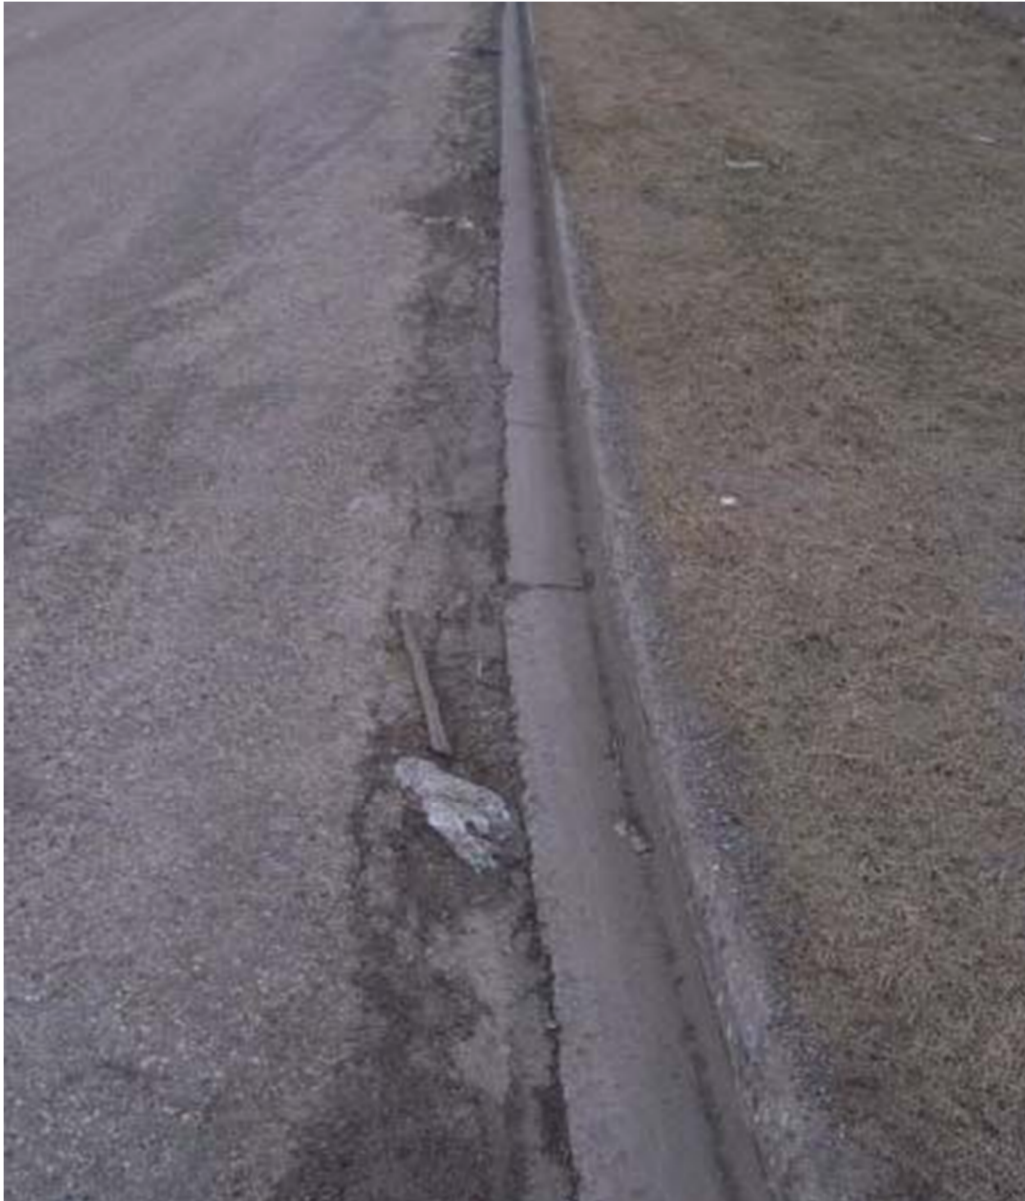
**Edge Deterioration**

Applies to areas typically within 0.6 metres of the pavement edge. This type of distress is typically found in locations where on-street parking lanes have been provided. The photo below is an example of moderate to severe edge deterioration.

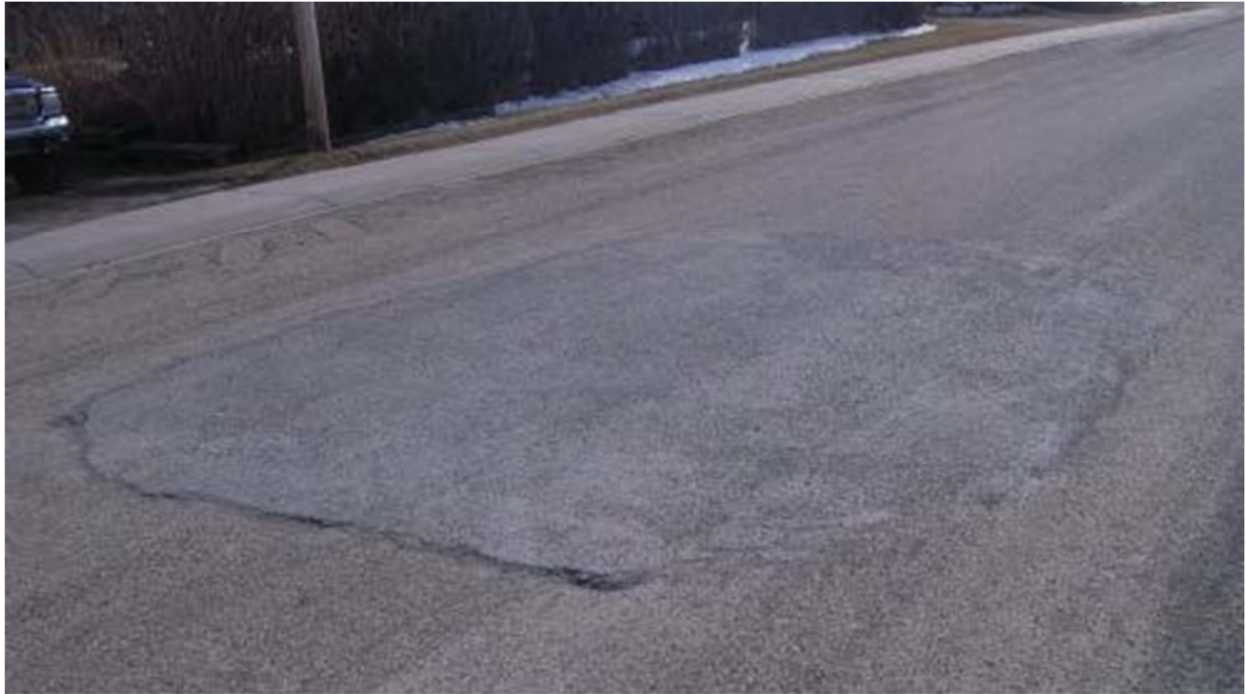
**Patching and Patch Deterioration**

Portions of the pavement surface, greater than 0.1 square metres that have been removed and replaced or additional material applied after the original construction. The photo below is an example of patching with minor deterioration.

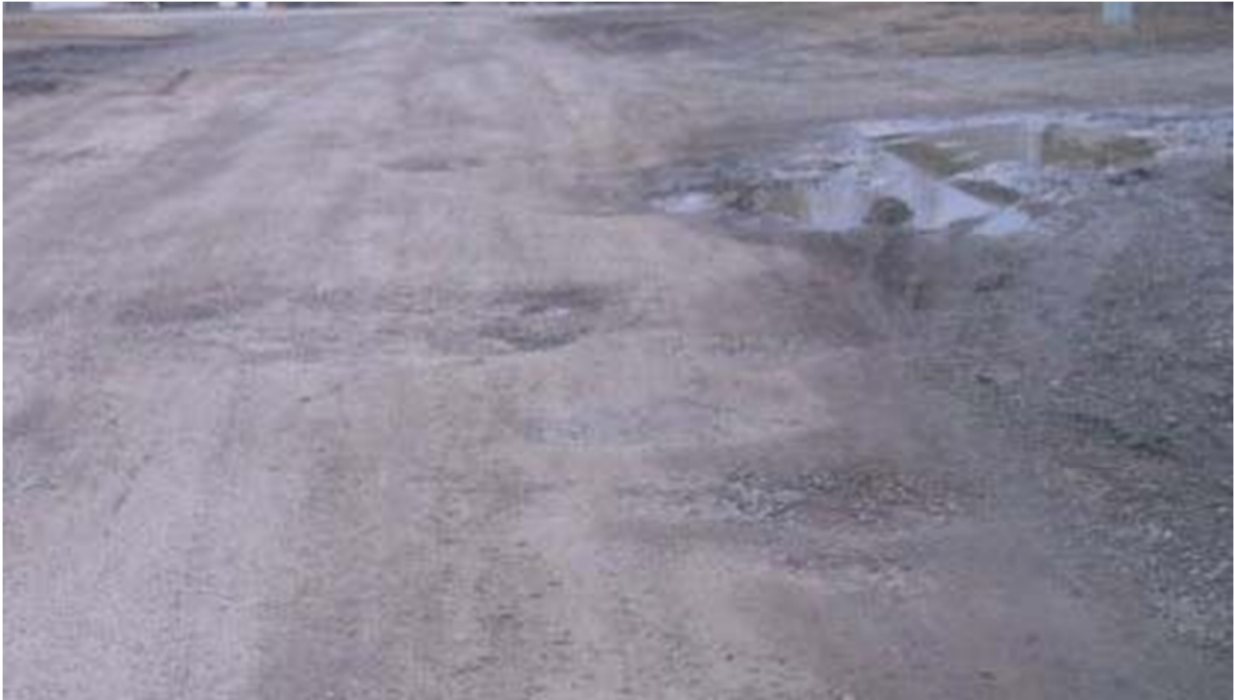
*Potholes*

Bowl-shaped holes of various sizes in the surface, often resulting in standing water and water infiltration into the base of the road structure. The photo below is an example of a roadway with many moderate to severe potholes where the roadway surface is heavily deteriorated.

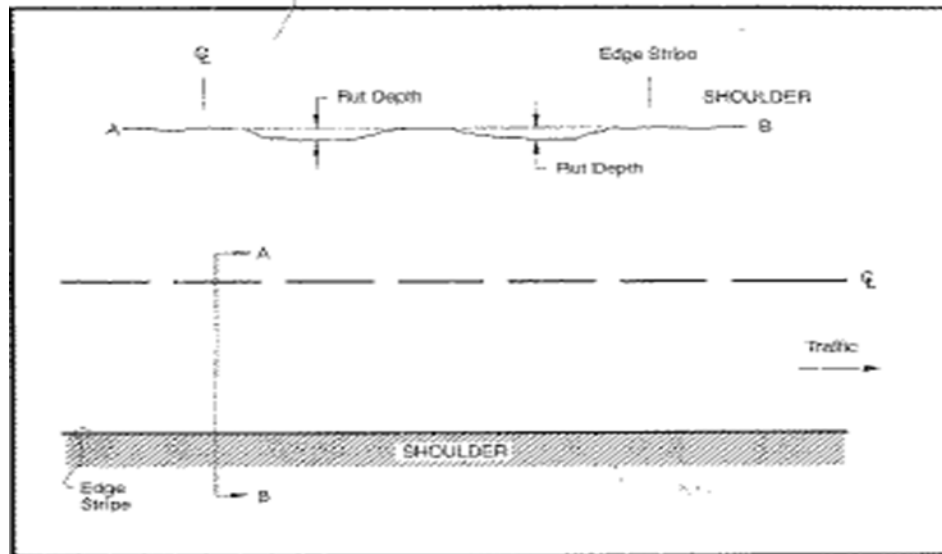
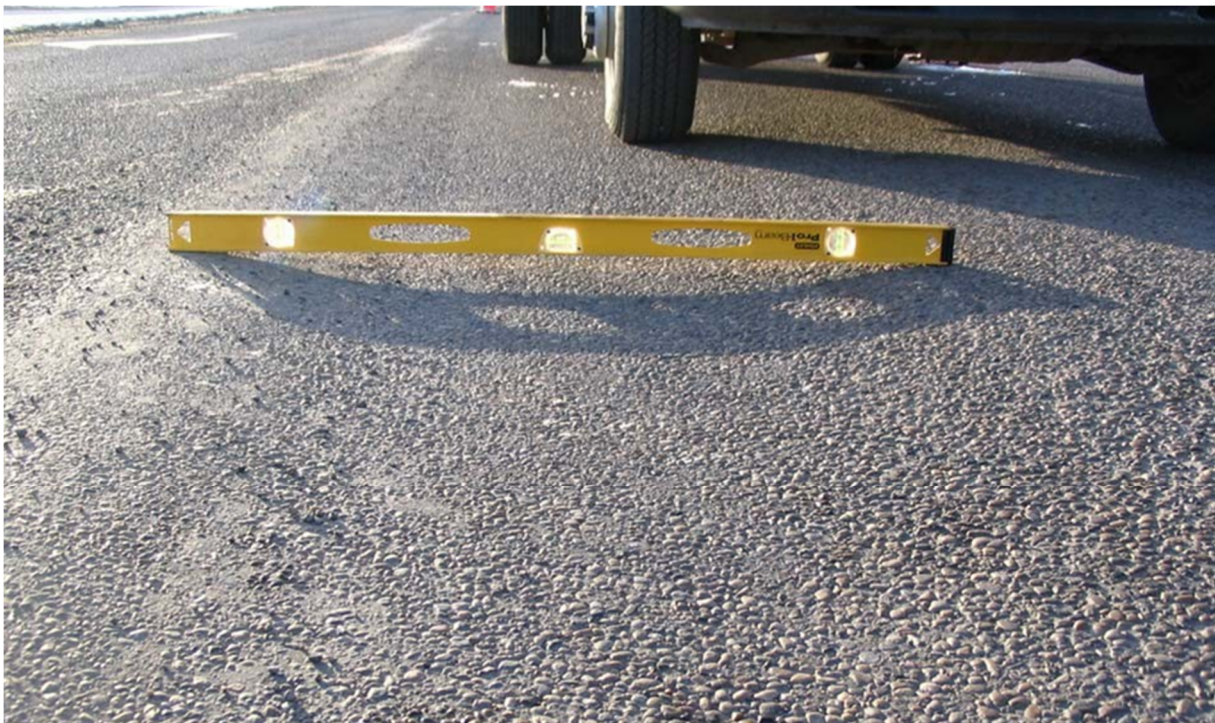
Rutting

A rut is a longitudinal surface depression in the wheel path which may have associated transverse displacements.

The photo below is an example of severe rutting.

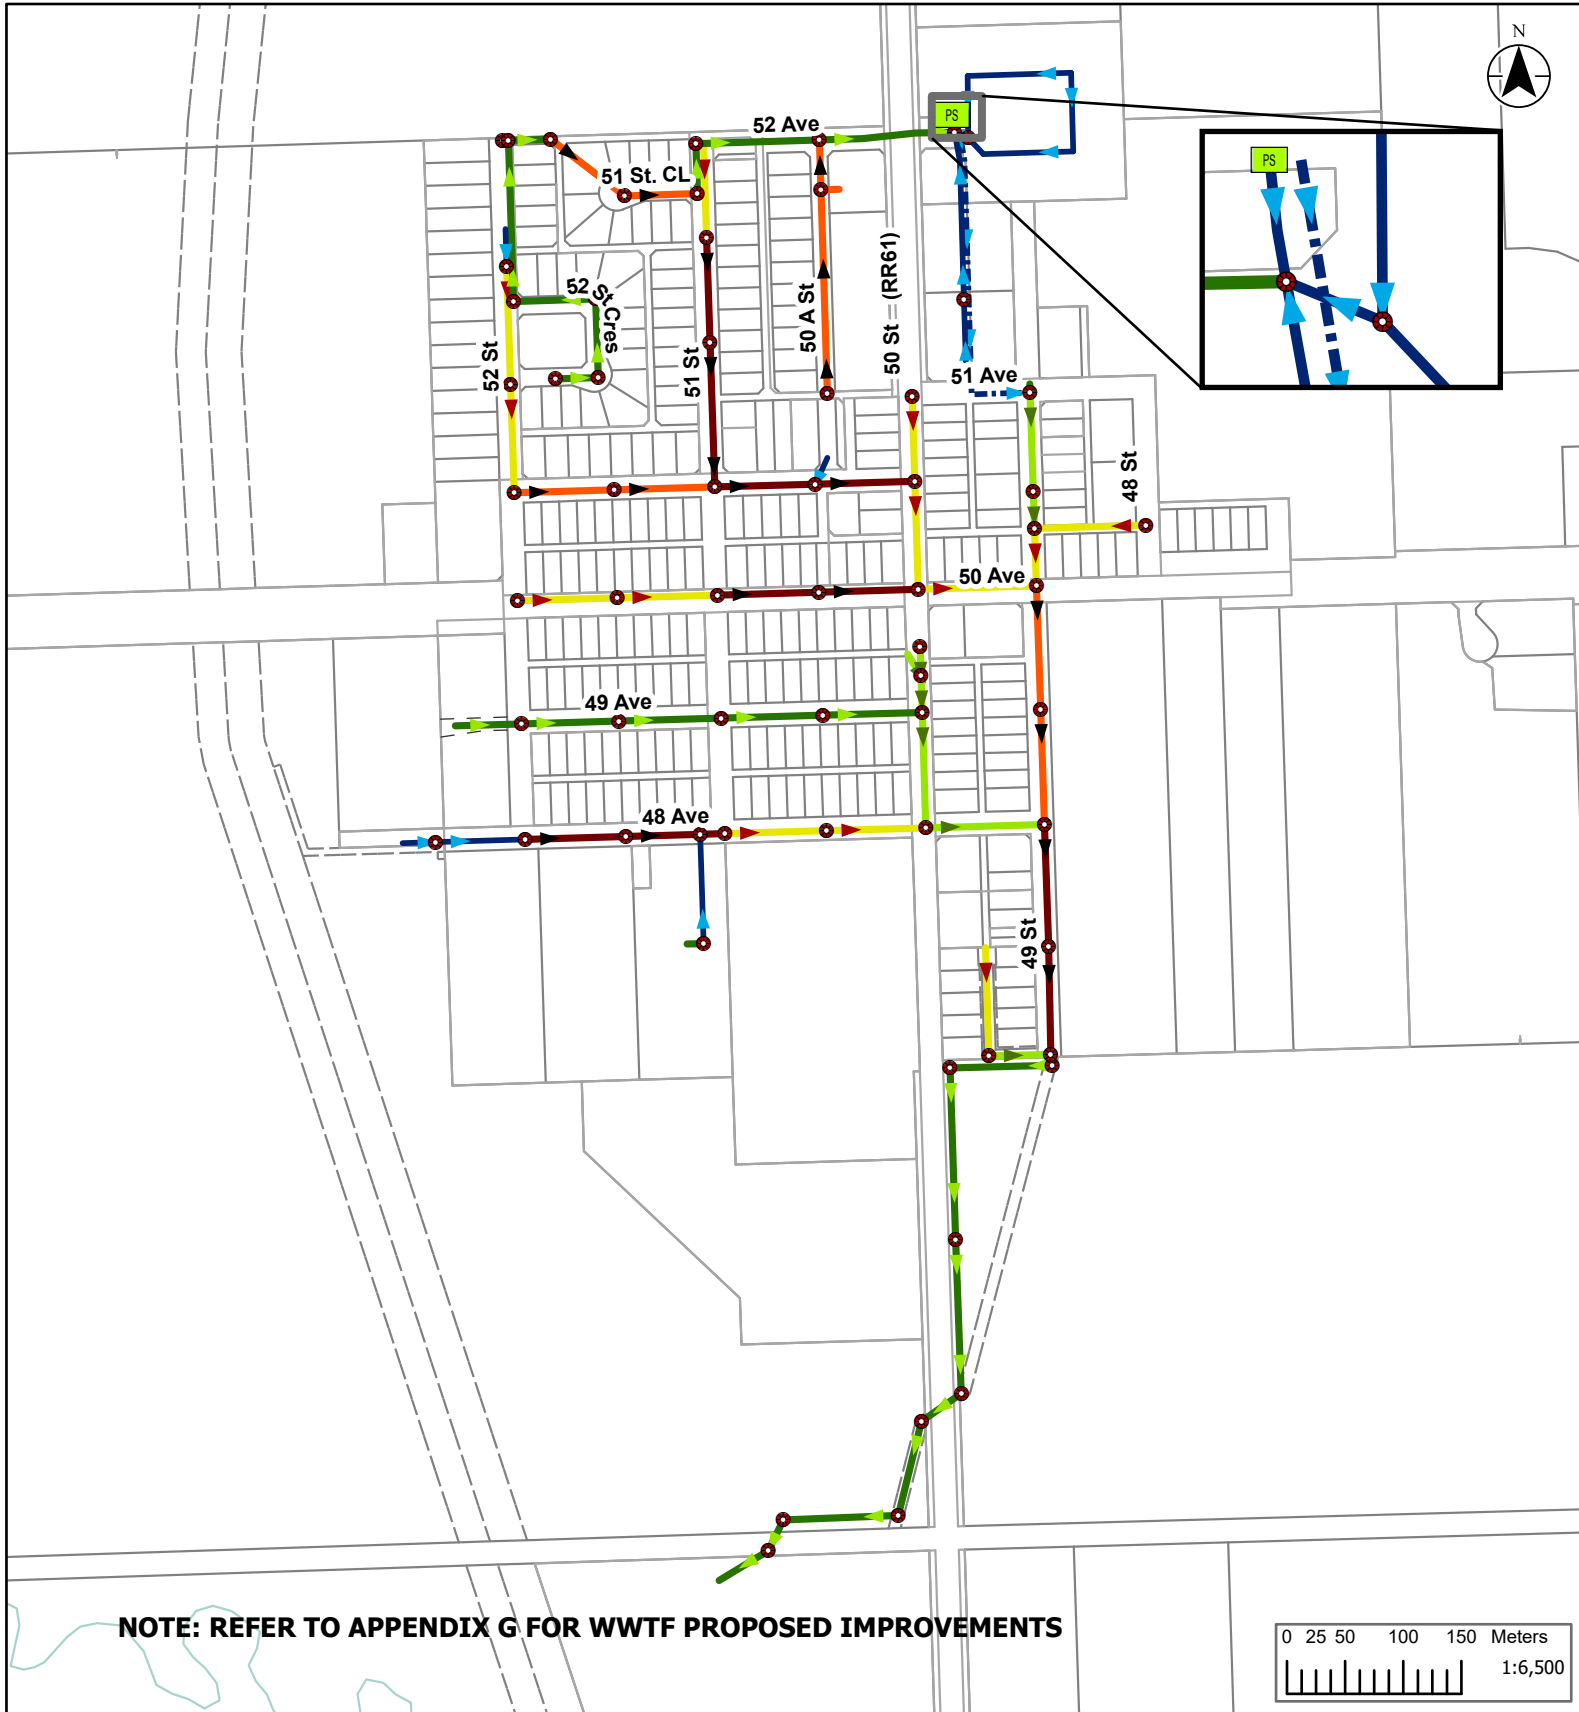
# VILLAGE OF CAROLINE: SANITARY SYSTEM

The sanitary sewer system Figure 3.1 in **Appendix B** outlines the sanitary sewer conditions. The approximate construction costs for the sanitary sewer replacement are based on the schedule provided in **Appendix B**. Where possible; sanitary sewer replacements for specific locations will be coordinated with watermain and roadway replacement to increase spending efficiency. Pipe sections with the lowest rating should be the priority for improvements.
